# Manhole Inspection Summary

Manhole # S41KK\_008MH

Insp Date: **6/9/09 10:34 AM**

**Location** Address: **1515 LAFAYETTE AVE**

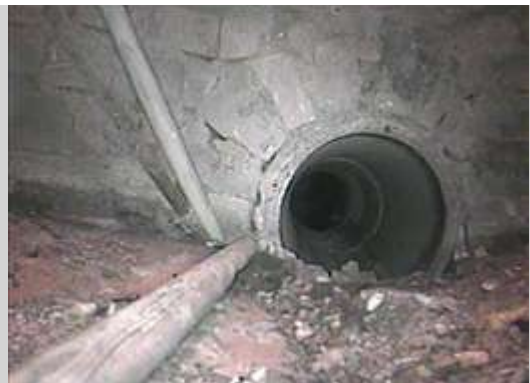
12 O'Clock Outflow

8 in. Circular Gravity Sewer  
Pipe Out @ 12 O'Clock

Infiltration: **None** Pipe Seal Cond: **Sound**
